# GEOSCIENCES DIVISION

## VULNERABILITY AND RISK ASSESSMENT

## VRA in Magallenes, Agusan del Norte:

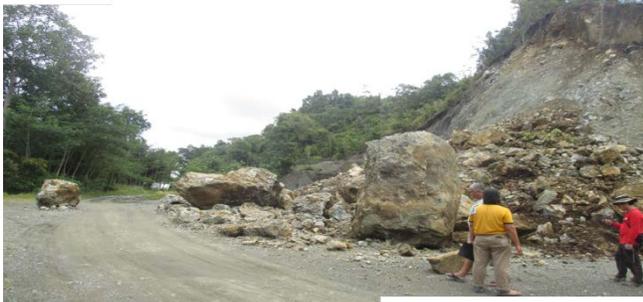
A rockfall incident in Purok 3, Brgy. Taod-oy with the debris materials blocking a segment of a gravel-paved secondary road (MGB fieldmen for scale).

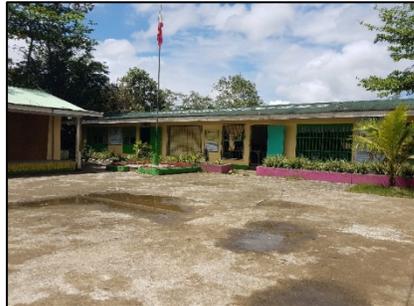
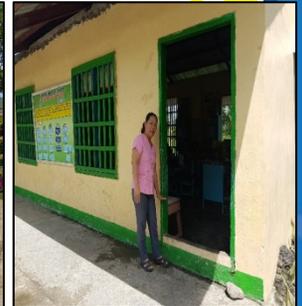
Guiasan Elementary School which is located in a flood prone area. Right photo shows a school teacher pointing the usual flood height experienced by the school during heavy rains.

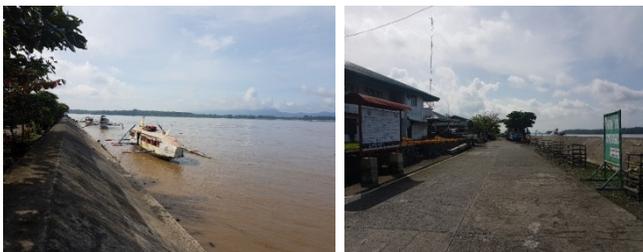
Photos show a river protection installed along the confluence of the Taguibo River to the Agusan River in Brgy. Poblacion in response to flood hazards.

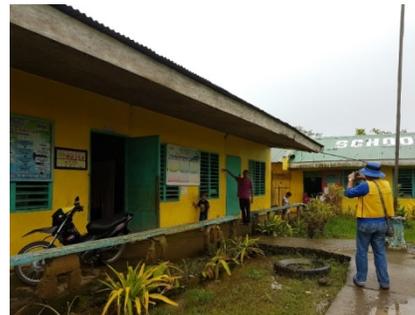
Pinana-an Elementary School at Brgy. Pinana-an, Las Nieves, Agusan del Norte are exposed to high to very High flood susceptibility.

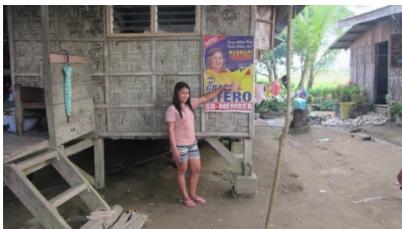
Local residence pointing out the highest flood height they experienced in Purok 3 of Barangay Concepcion. Geographic coordinates 7° 59' 06.4" north latitude 126° 00' 12.1" east longitude.

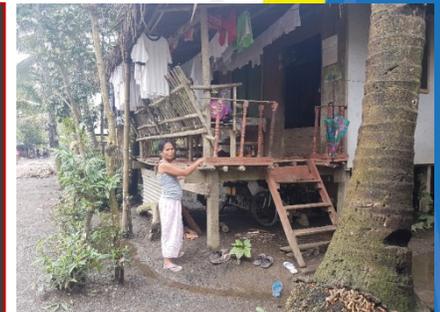
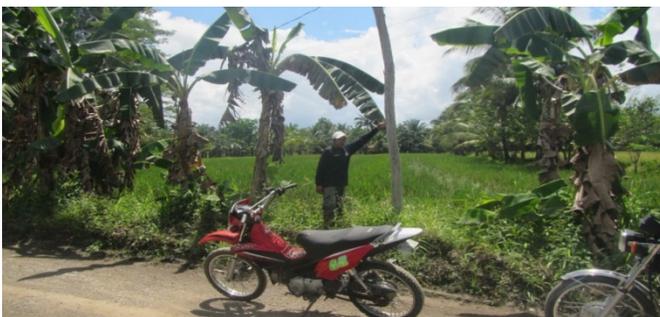
Photo shows residence pointing out the highest flood level of road network going to Aurora Elementary School in Purok 4 Barangay Aurora. Inaccessible when heavy rainfall strikes. Geographic coordinates 8° 00' 49.8" north latitude 126° 01' 03.5" east longitude

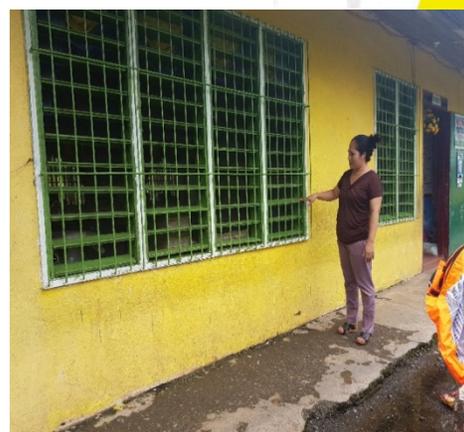
Lingayao Elementary school in Brgy. Lingayao, Las Nieves, Agusan del Norte is exposed to moderate to high flood susceptibility.

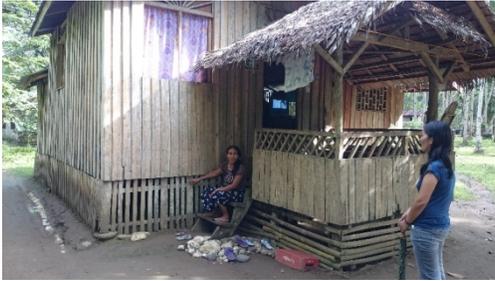
Residents of Prk. 5, Brgy. Tag-oyango, Las Nieves, Agusan del Sur are exposed to moderate flood susceptibility.

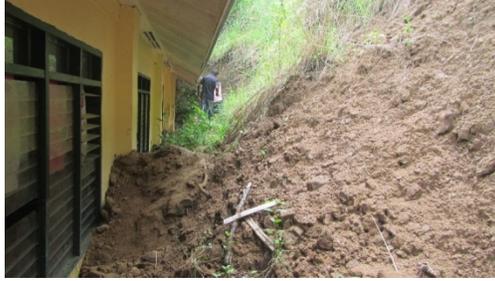
A landslide at the back of one of the school building in San Isidro Elementary School in Brgy Afga occurred last April 2017 due to heavy rainfall.

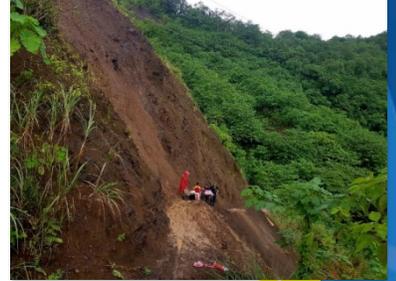
Road cut along Prk 5, Sitio Kahayagan, Brgy. Del Rosario, Sibagat, Agusan del Sur - named as "Tacluban" due to frequent landslide along the road due to very steep slope. rainfall.

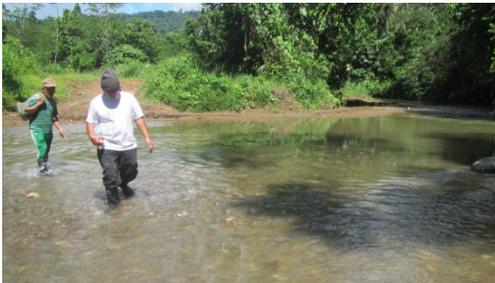
Photo of Bitaugan creek going to Brgy Bitaugan proper, unable to cross during heavy rainfall due to increase of water level. Geographic coordinates 9° 02' 19.0" North latitude 125° 53' 48.2" East longitude.

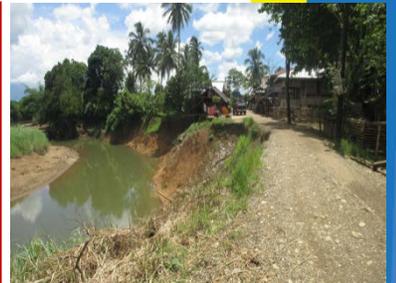
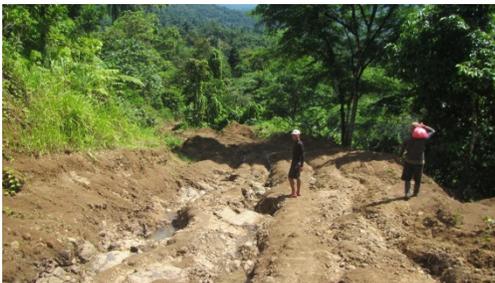
Road network going to Barangay Bitaugan showing muddy and highly damage which hard to access on motorcycles crossing the road. Geographic coordinates 9° 01' 42.4" North latitude 125° 53' 28.5" East longitude.

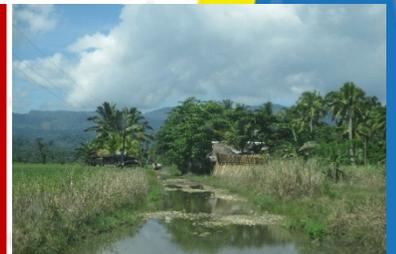
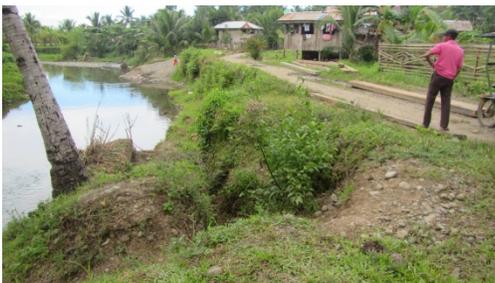
Active river scouring in Cagdao creek embankment spotted in Purok 5-B of Barangay Castillo. The observed scoured was almost hit the access road in the area. Geographic coordinates 8° 54' 53.6" North latitude 125° 57' 55.0" East longitude.

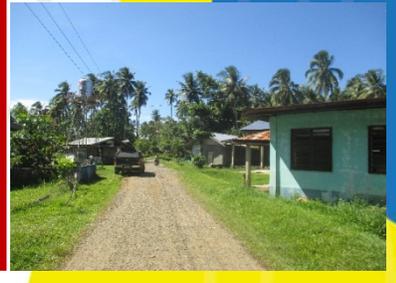
Farm-to-market road in Brgy. Badong which is very high in flood inundation, about 2 meter flood height is reported due to riverine flooding from the Tago River.

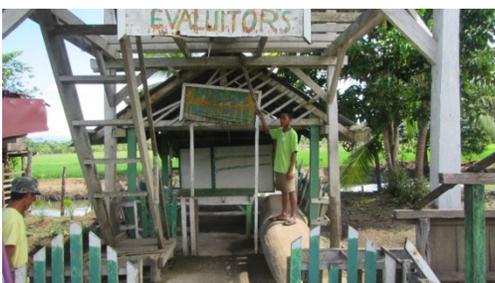
Photo of local residence in Barangay San Roque Purok Daan II pointing out the highest flood height they experienced. Geographic coordinates 8° 54' 14.7" North latitude 126° 00' 14.3" East longitude.

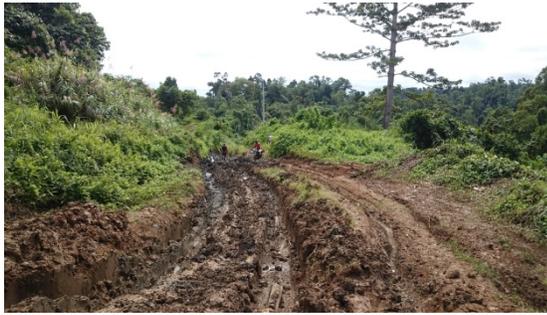
Road network going down to Barangay Binicalan proper showing muddy and rough, difficult to access on motorcycles crossing the area especially in bad weather condition. Geographic coordinates 8° 22' 26.4" north latitude 125° 33' 17.7" east longitude.

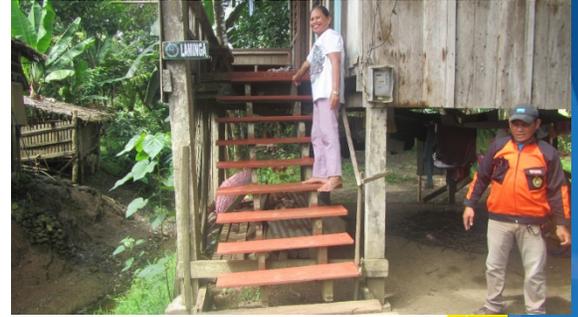
Local residence point out the highest level of flood water they experienced during heavy rainfall and typhoon located in Purok 3 Barangay Don Alejandro. Geographic coordinates 8° 26' 38.5" north latitude 125° 43' 11.8" east longitude.

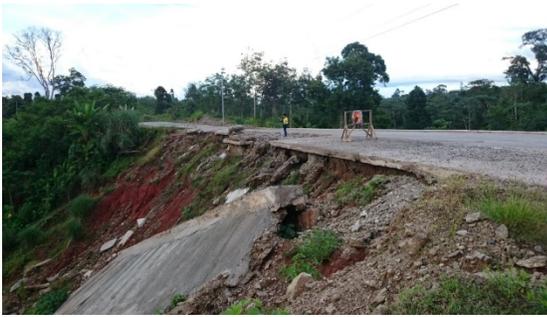
Massive landslide at road network Purok 7 Barangay Don Alejandro occurred last January 2017 brought by intense heavy rainfall. Geographic coordinates 8° 23' 32.5" north latitude 125° 41' 02.7" east longitude.

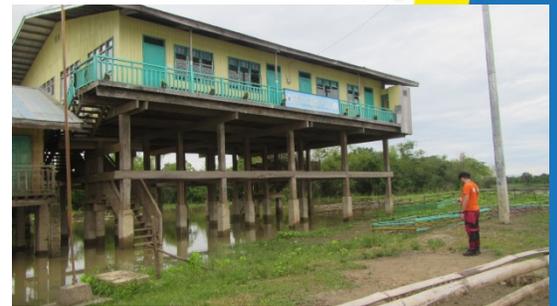
Geotagging of Sabang Gibong Elementary School in Purok 1 Barangay Sabang Gibong. School building was installed on elevated flooring with approximate height of 2.50-3.0 meters to avert flood hazard. Geographic location 8° 19' 24.78" north latitude 125° 53' 18.4" east longitude.

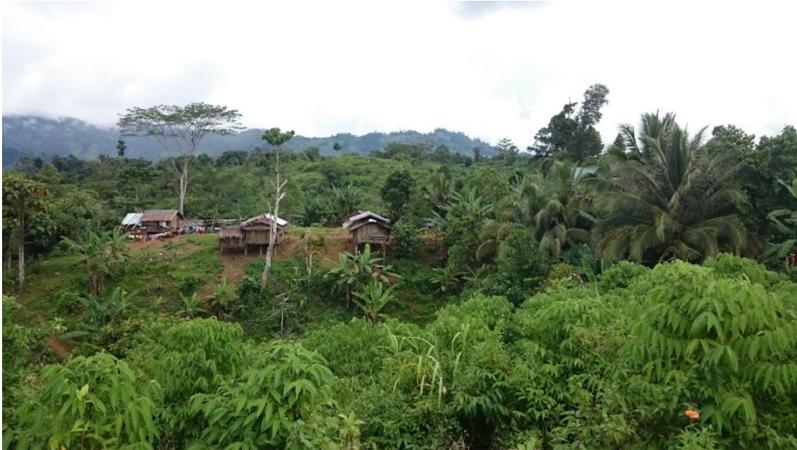
View of residential houses in Sitio Tumulog Barangay Zillovia located on a slope terrain. Barangay Zillovia falls under moderate to high landslide susceptibility. Geographic location 8° 20' 23.2" north latitude 125° 31' 28.4" east longitude.

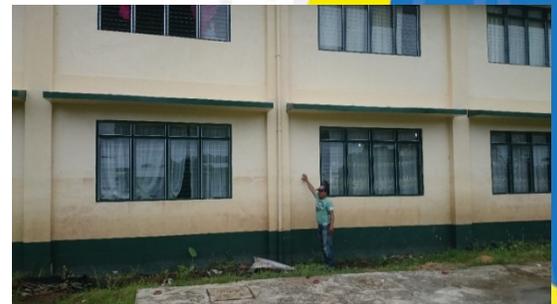
Local residence pointing out the highest flood height they experienced in Purok 3 Barangay San Nicolas. Building on the picture is the Talacogon National High School. Geographic location 8° 27' 31.1" north latitude 125° 46' 51.7" east longitude.

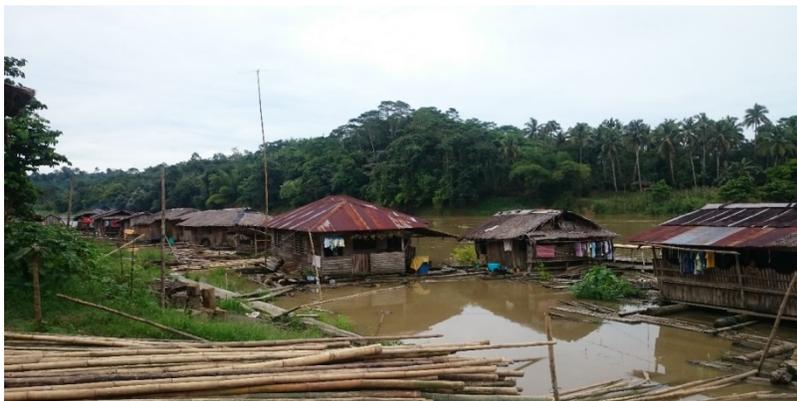
View of floating residential houses situated in Agusan River Purok Sampa Barangay San Agustin, which are highly prone to flash floods. Geographic location 8° 27' 05.2" north latitude 125° 47' 13.9" east longitude.

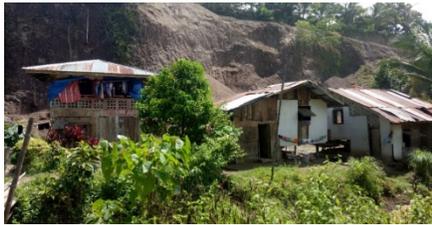
Photo showing 3 houses was observed near landslide prone area located at Purok 8, Bunawan Brooks, Bunawan. This site is a quarry for backfilling purposes. The wall is estimated to be around 15 – 20 meters. Distance from the house to the wall is ranging 3 – 5 meters.

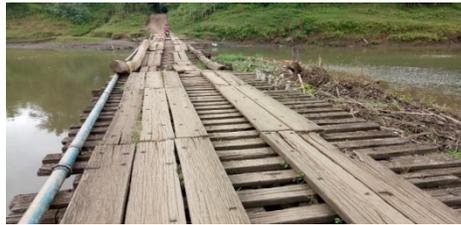
Photo showing the condition of bridge from Libertad proper going to Purok 9 along Simulao River. GPS Coordinates: N8 06 28.6 E126 01 33.7

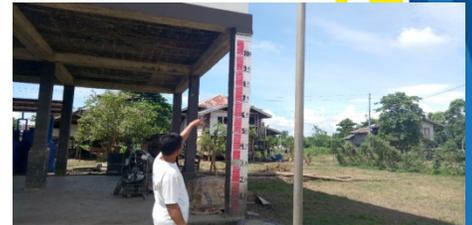
Photo showing the flood height markers on the post of Evacuation Center in Campo 6, Barangay Nueva Era were flood height reaches up to 9 ft.

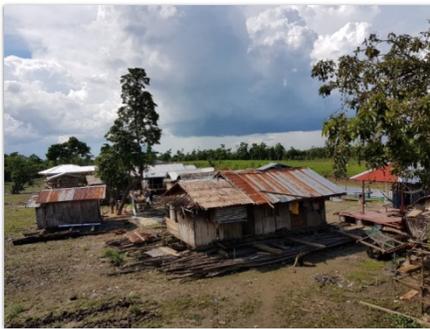
Floating houses of Prk. 7, Brgy. San Marcos, Bunawan, Agusan del Sur are exposed to very high flood susceptibility

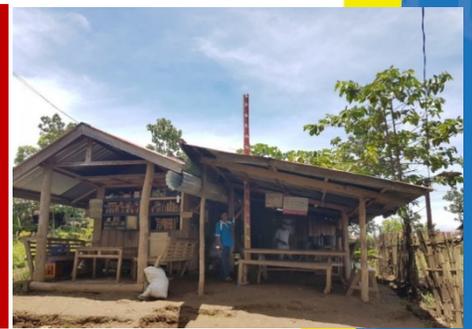
Houses exposed to high to very high flood susceptibility at Prk 2, Brgy. San Marcos, Bunawan, Agusan del Sur

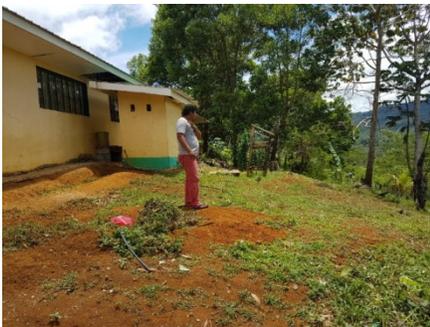
Photo showing the Jose Cuyos Sr. Elementary School is located in a landslide prone area. This picture is facing east. Geographic Coordinates: N8 18 02.4 E126

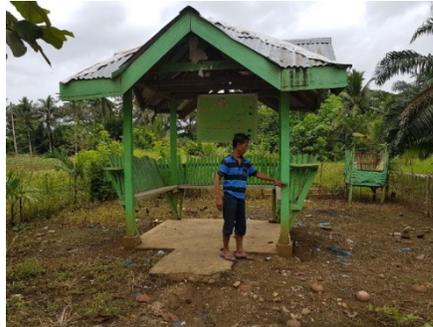
Sheet flooding was observe along barangay site of Tagabayan, Rosario. Geographic Coordinates: N8 22 10.1 E125 58 05.1

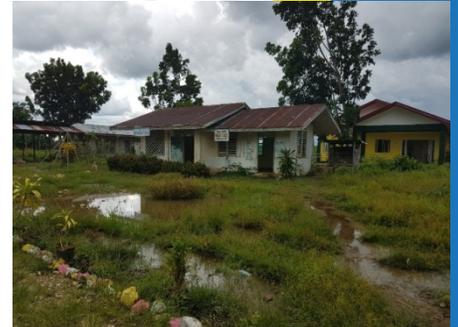
Photo showing the flood height in Purok 4, Wasi-an.

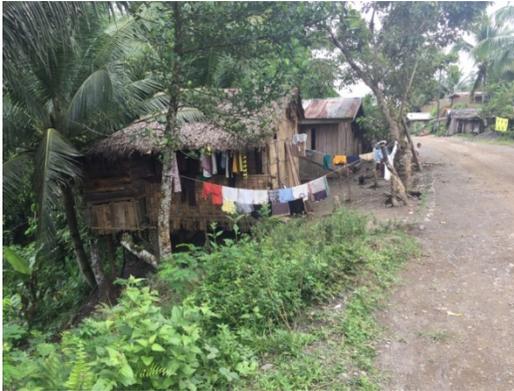
Located at Purok 1 of Brgy. Valentina, La Paz. Photo showing houses built along the cliff, it is susceptible to moderate to high landslide. Creeping was observed along the area, tilting of coconut trees are one of the indicator of the ground movement. Which mean the ground is slowly moving which can be trigger by heavy rains and cause extreme ground movement.

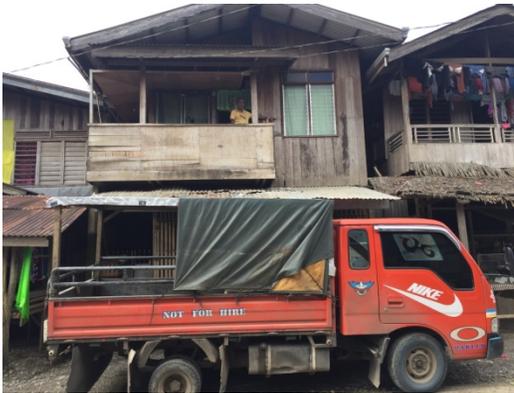
Located at Purok 1 of Brgy. Panangagan, La Paz. Photo showing the flood height (red line), estimated 5 meters, during the extreme flooding happened in the Municipality last January 19, 2017. Overflow and backflow of the Adgawan River, Mah-mah creek and Panangagan creek are the main cause of the flooding of the said area.

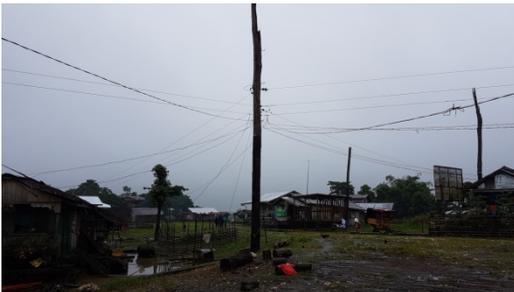
Flood height (red line) of about 5-6 meters in Purok 1 of Barangay Sabang Adgawan due to overflow of Adgawan, Agusan, and Hibong River during the Typhoon Auring on January, 2017. The ponding of water lasted for about 4 months according to anecdotal accounts from the local residents. The area falls under very high susceptibility to flooding.

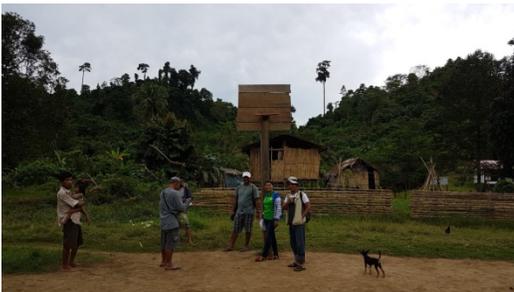
Flood height (red line) of about 3-4 meters in Sitio Minduyog of Barangay Lydia due to overflow of Adgawan River during the Typhoon Auring on January, 2017. The area falls under the category of very high flood susceptibility.

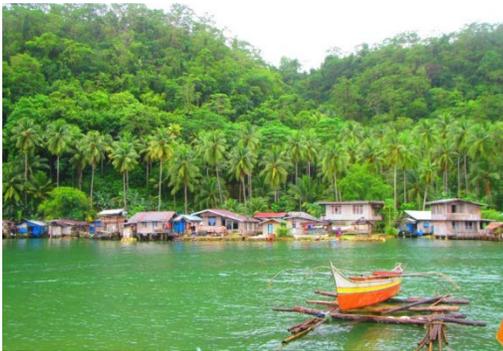
Houses along the coast in Brgy. Gamut which aside from being prone to coastal hazards, are also prone to rock fall from nearby steep slopes. Located in Barobo, Surigao del Sur

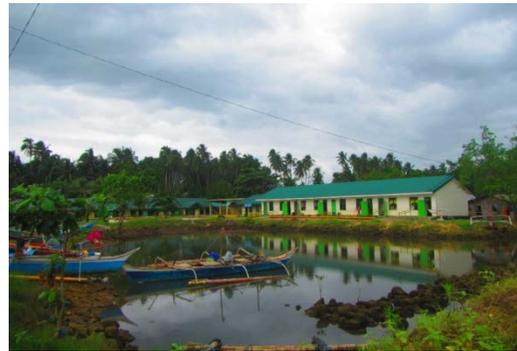
A view of Talisay Seaside Elementary School near the mangroves area in Brgy. Poblacion which is prone to coastal hazards. Located in barobo, Surigao del Sur

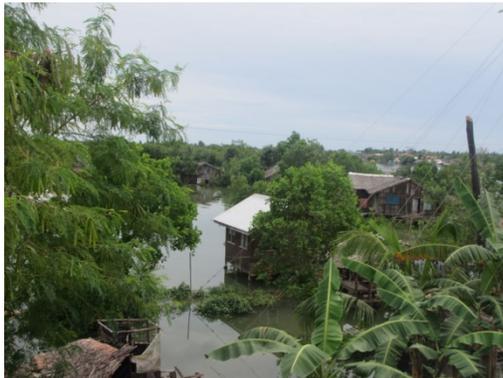
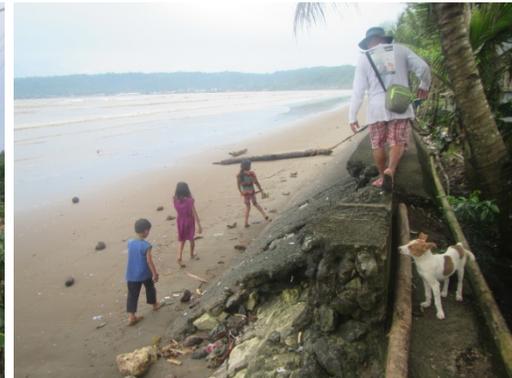
Damages observed on the seawall along the coast in Brgy. Poblacion.

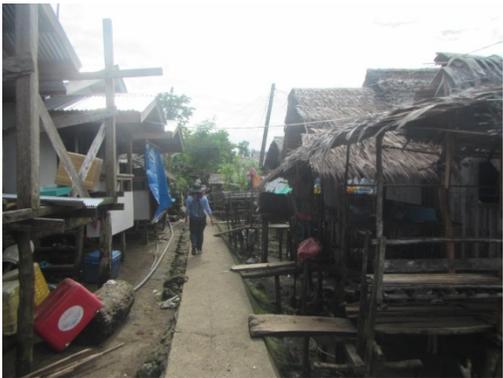
Houses in Brgy. Tidman built beyond the seawall making them unprotected and vulnerable to coastal hazards.

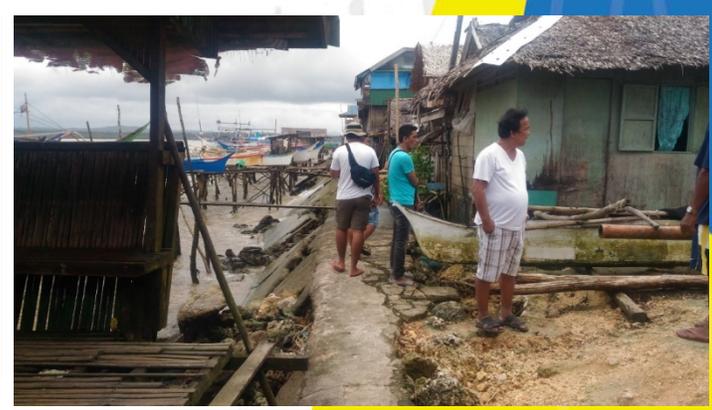
Damages observed on the seawall in Brgy. Lacasa which are the effects of storm surges during typhoons that hit the area.

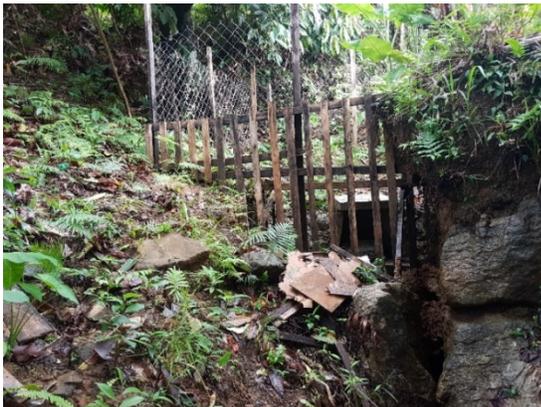
Basilisa, Province of Dinagat Islands

Water source in Purok 5, Brgy. Diegas, Basilisa is a spring enclosed by concrete box and supplies Puroks 3, 4 and 5. According to residents, they experience low discharge of water especially during summer.
