#### PROGRAM 1: GEOLOGICAL RISK REDUCTION AND RESILIENCY PROGRAM

##### Geological Assessment for Risk Reduction and Resiliency Program (Geoscience Development Services)

##### Vulnerability & Risk Assessment & Updating

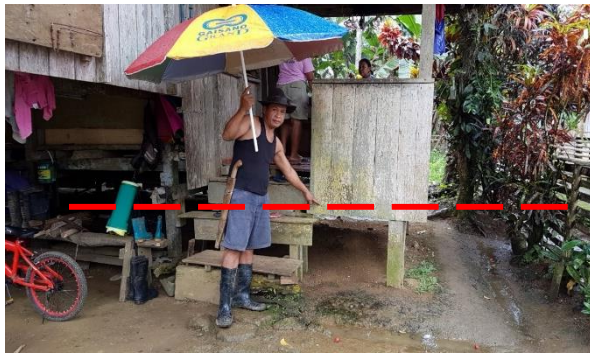
Flood height (0.75m) in Purok 1 of Barangay Batunan near the Batunan Elementary School. The Hinatuan River and Candiisan River contributes to the moderate flood susceptibility in the area.

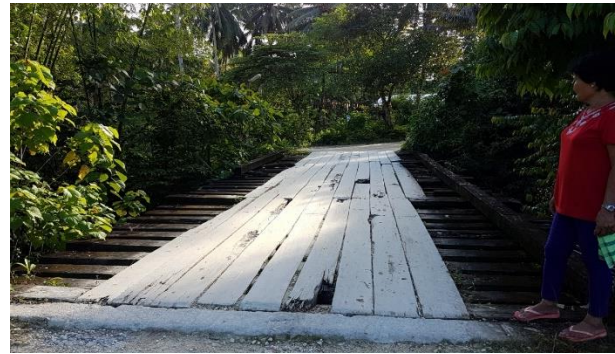
Wood bridge constructed over Linaw River (Subang Linaw) located at Purok 7 of Barangay Magsaysay. The bridge was flooded during typhoon Sendong and Pablo. Local residents evacuate on the nearby elevated area during the flood event.

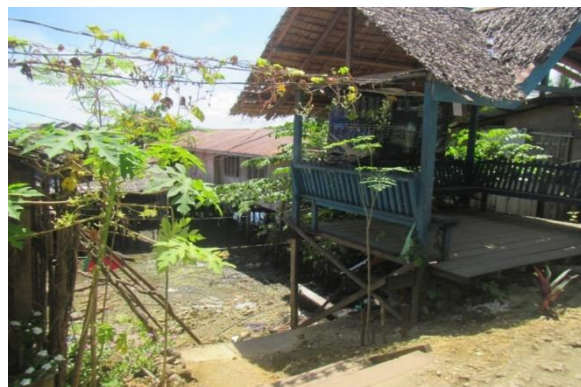
Purok 1-4 houses in Brgy. Liamtico vulnerable to tidal flooding due to proximity in shoreline  
Geographic Coordinate: 8° 33' 57.1" N 126° 6' 44.4"E

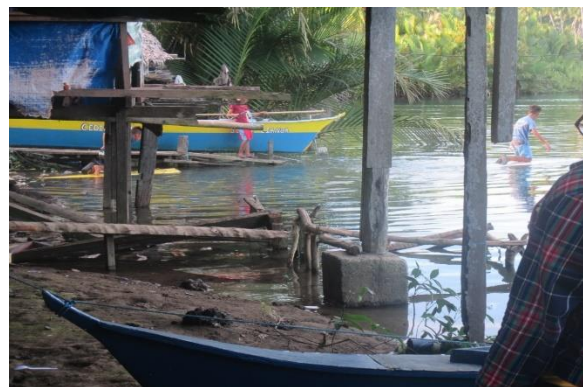
Agac-Ac River in Purok 4 Brgy. Poblacion with no levee or dike to protect the nearby houses and road.

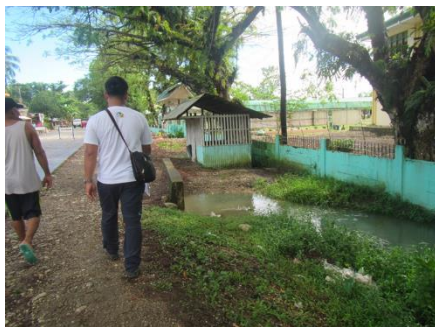
Drainage canal in Brgy. Hornasan near Sto. Niño National High School is not sufficient and may cause localized flooding in the area.

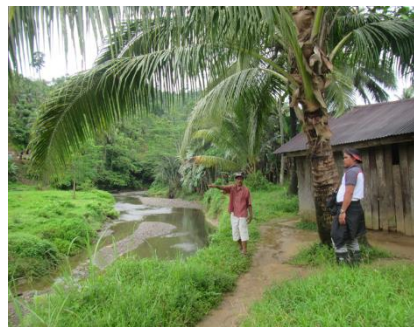
Overbank flooding occurs when the river channel overflow during heavy rains affecting the residents in Purok 3 Brgy. Janipaan

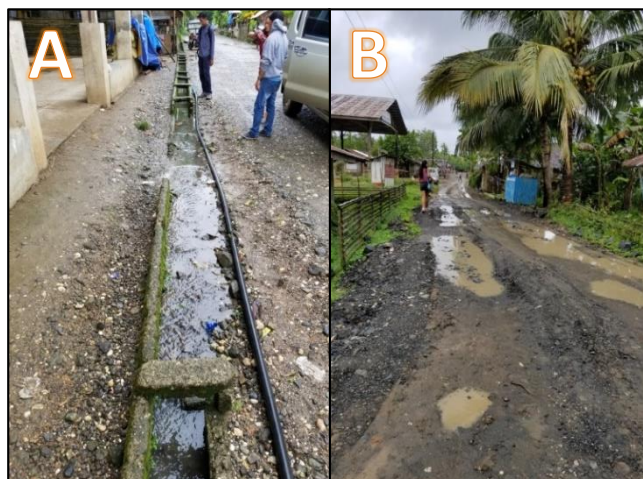
Shallow and damaged drainage canal adjacent to the gymnasium in Purok 3 of Barangay Amontay is noted and geo-tagged. Water overflows during moderate to heavy rainfall. Drainage systems or lack of it are essential factors which affect the flood situation of the area especially during typhoons. Important conditions, such as this, are noted for the technical report and updating of geohazard maps.

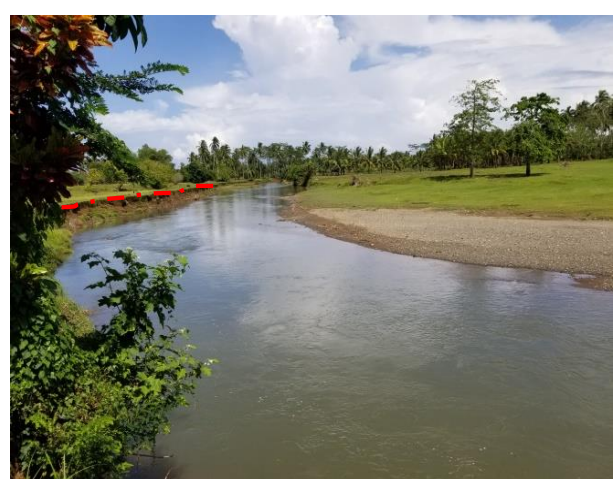
Active scouring (on red dashed lines) of the outer meander of the river in Purok Nangka of Barangay Bayan is noticeable as seen on the upper left side of this photo. The behavior of rivers like flow direction and current are correlated to communities and existing infrastructures adjacent to the area with regards to flood susceptibility.

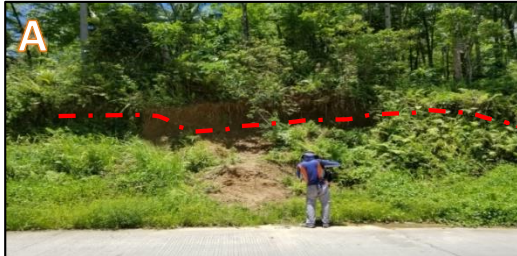
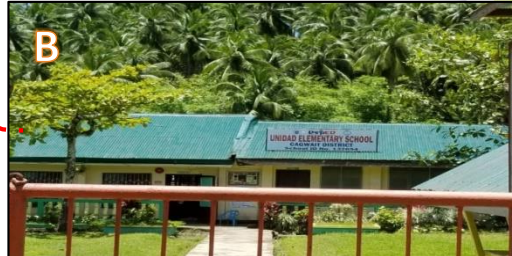
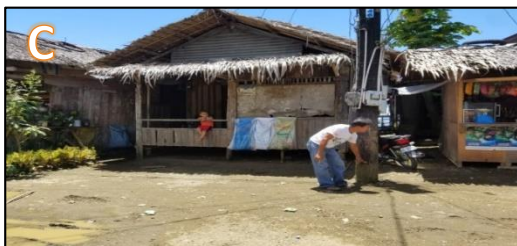
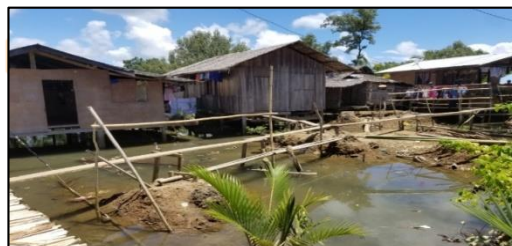
Landslide and flood prone areas are noted in Barangay Unidad. Photo A shows recent manifestation of such event along the concrete road of Purok Mondalo. Debris fell from an approximately 3-meter high area (red dashed lines) but did not reach the road. There were no mitigating measures seen during the conduct of assessment. Unidad Elementary School (Photo B) in Purok Brotherhood sits on a foot slope. Trees such as coconut dominate the area which helps hold and stabilize the slope's angle of repose. A resident of Purok Mondalo showing the flood height (red dashed lines) experienced in the area which is about half a meter (Photo C). Lastly, Photo D shows slightly elevated houses due to stagnant flooded area in Purok Riverside.

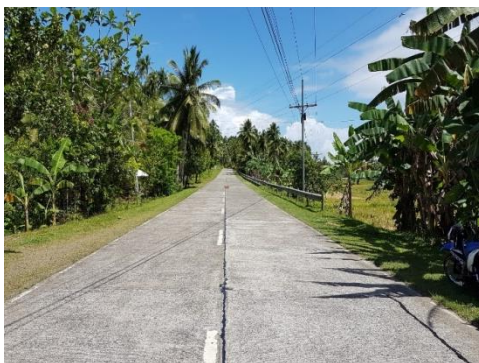
National highway going to Tandag in Barangay Cagbaoto which is always flooded during intense rainfall. Highest flood height recorded was 1 meter according to anecdotal accounts.

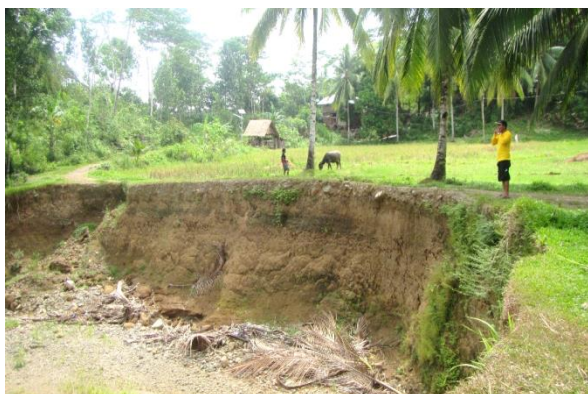
View of River Scouring at Purok 8 of Barangay Mabahin due to typhoon Basayang affecting the road on the way to Purok 4 of the Barangay. Geographic location 9° 11' 11.15" North latitude 126° 10' 7.36" East longitude.

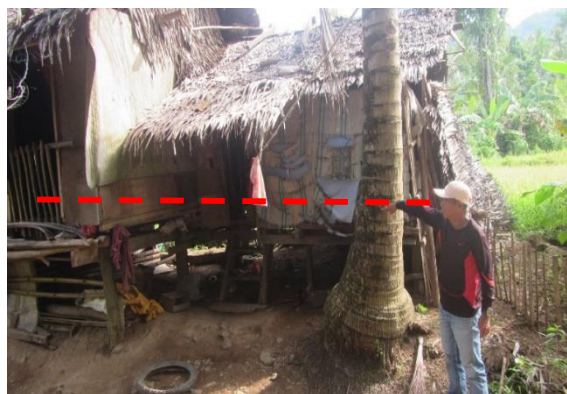
MDRRMC personnel pointing out the highest flood height approximately 1.5 meters rated as high flooding experience by the residence of Purok 7 Barangay Tigao. Geographic location 9° 13' 6.1" North latitude 126° 10' 5.45" East longitude.

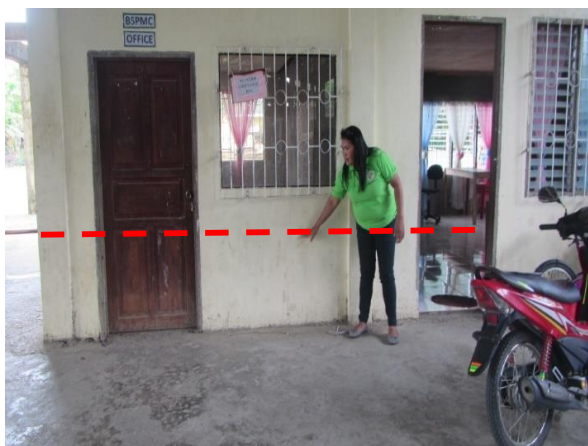
Office hall of Barangay Bunga located at Purok 2 experienced moderate flooding approximately 1.0 meters height. Geographic location 9° 15' 18.54" North latitude 126° 0' 32.29" East longitude.

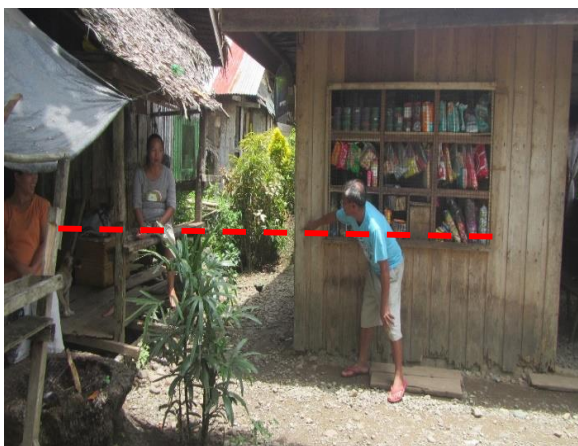
Purok 2 Barangay Agsam experienced moderate to high flooding approximately 1.20 meters. Geographic location 9° 13' 0.77" North latitude 126° 2' 33.04" East longitude.

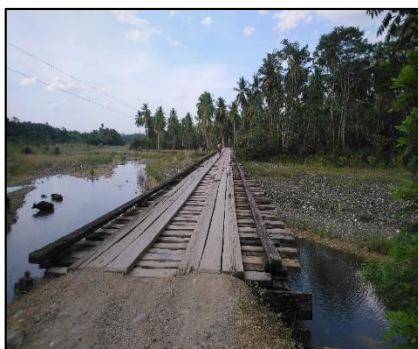
This photo shows the condition of the old bridge located in Brgy. Hinapuyan which connects Brgy. Hinapuyan going to Carmen proper.

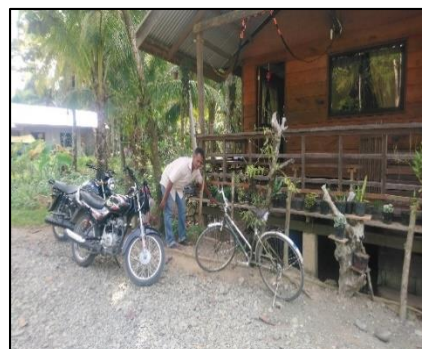
Photo showing the flood height located in Purok Duranta, Brgy. Poblacion in which indicates as low flooding. GPS Coordinates: N9.24035 E126.02542

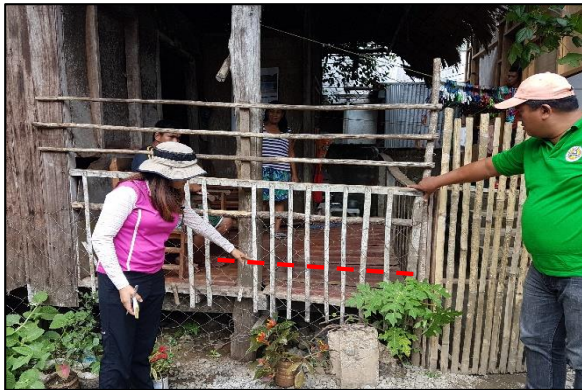
Residents in Purok 6 pointing the highest flood height they experienced during Typhoon Basyang.

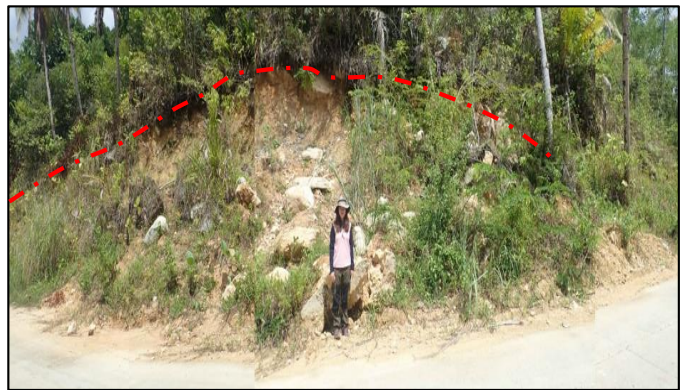
Landslide was observed along the road cut of Brgy. Consuelo to Brgy. Magasang route.

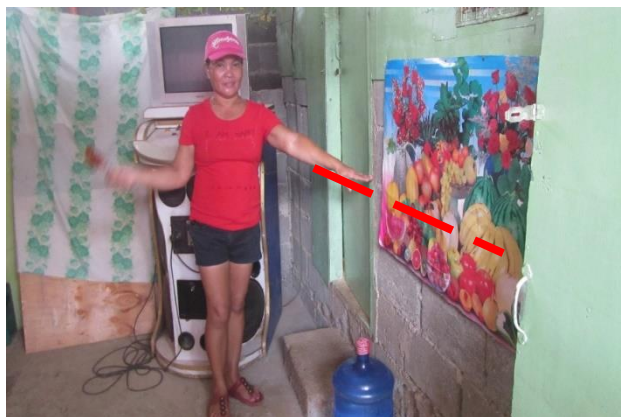
Photo showing the high flood height experienced in Purok 6, Barangay Adlay, Carrascal, Surigao del Sur. GPS Coordinates: N9° 24' 33.7" E125° 53' 52.3".

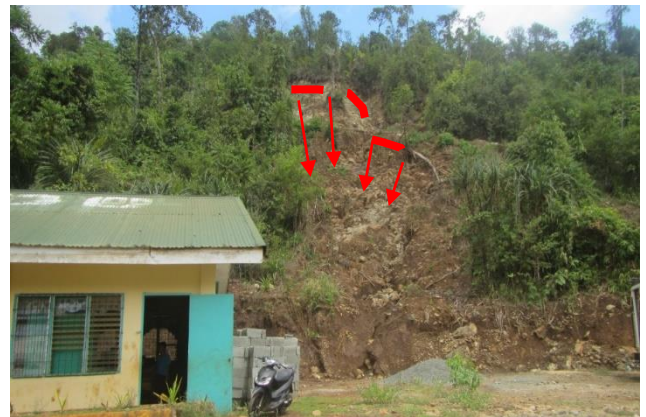
A landslide observed near a building in Camp David Primary School located in Purok 8- Sitio Ban-ban, Barangay Panikian, Carrascal, Surigao del Sur. GPS Coordinates: N9° 19' 45.2" E125° 54' 50.9".

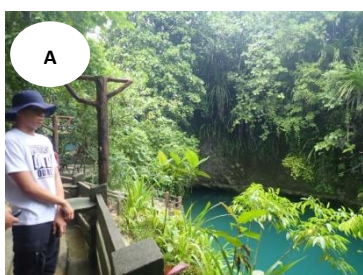
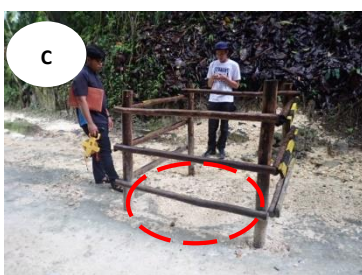
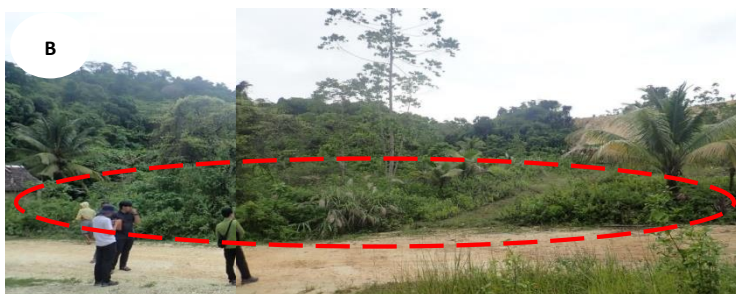
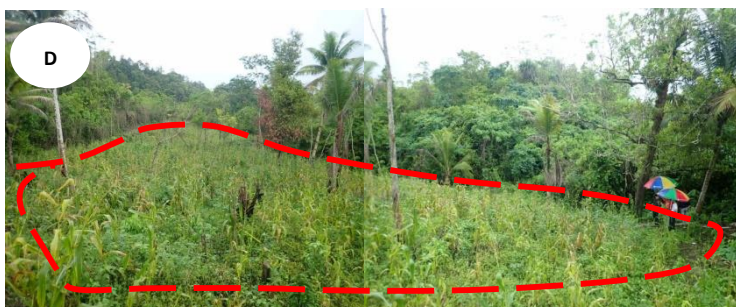
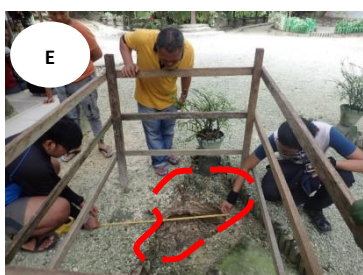
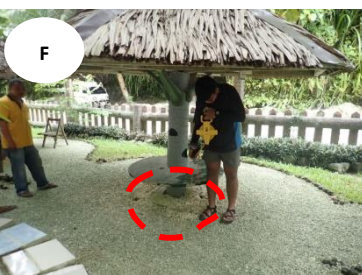
**A)** Cover solution observed at Enchanted River about 74.40 meters. **B)** Cover subsidence adjacent to Enchanted along road going to Barangay Cambatong. **C)** Cover collapsed noted along road going to Enchanted River approximately 1.30 meters in diameter. **D)** Photo of cover subsidence along the road going to Barangay Cambatong. **E)** A cover subsidence type of sinkhole located at lagoon area of enchanted River. It is approximately 0.70 meters in diameter and 0.3 meters depth. **F)** View of cover collapsed type of sinkhole located at the second cottage from the restroom of enchanted river.

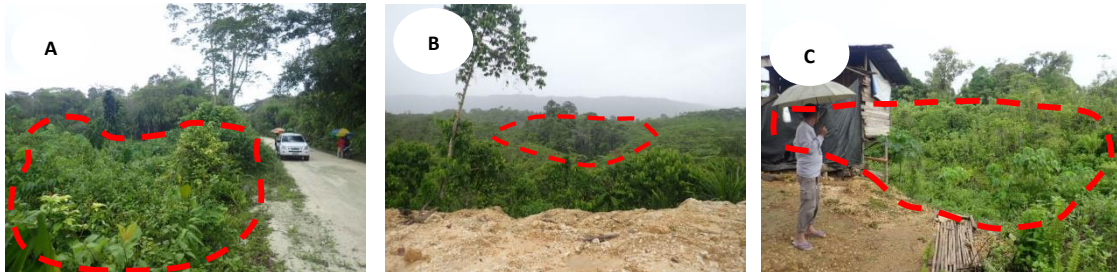
**A)** Cover subsidence going to Barangays Portlamon, Campa, Harip and Baculin. **B)** Cover subsidence showing distinct vegetation along road to Barangay Cambatong with road outcrop. **C)** A cover subsidence type of sinkhole situated at Sitio Dreamland-B behind residential house and Sitio Hall.

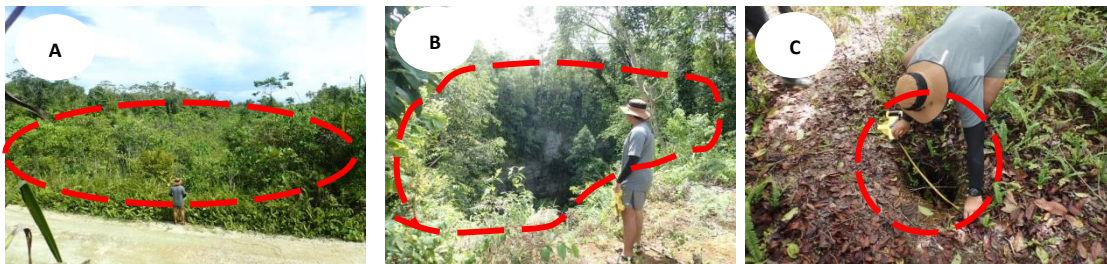
**A)** View of Cover subsidence type of sinkhole located along the road on the way ton Barangay Baculin close to intersection. **B)** Massive cover solution a type of sinkhole located at Purok 1 Sitio Airport. Bottom of the sinkhole is where the water source of Sitio Airport is located. **C)** A cover solution near/adjacent to the massive sinkhole (B).

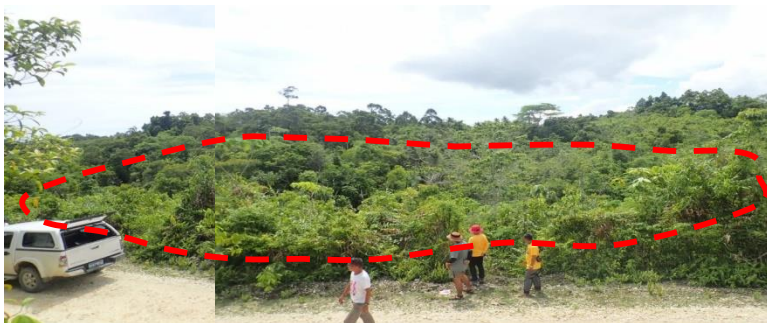
Cover subsidence observed along the road going to Barangay Harip.

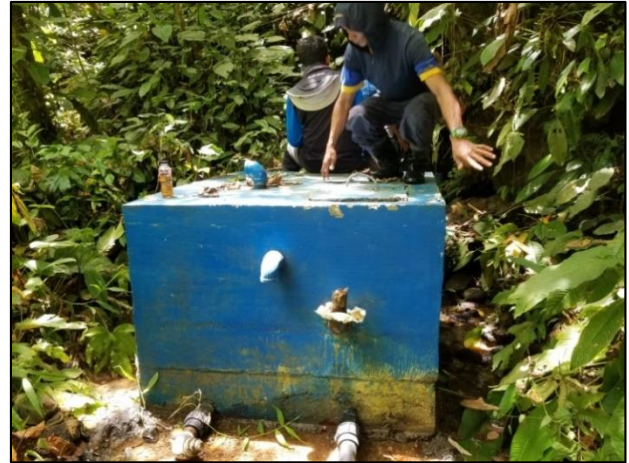
Photo shows the location and situation of the water source supplying Barangay Kasapa II excluding its sitios. A SALINTUBIG project in 2016 provided the residents the means to access from the source to the barangay proper with four (4) tap stands. The water is used for drinking and domestic purposes. However, there are days when water could not flow because of the blockage of sediments in the source so maintenance is needed from time to time.

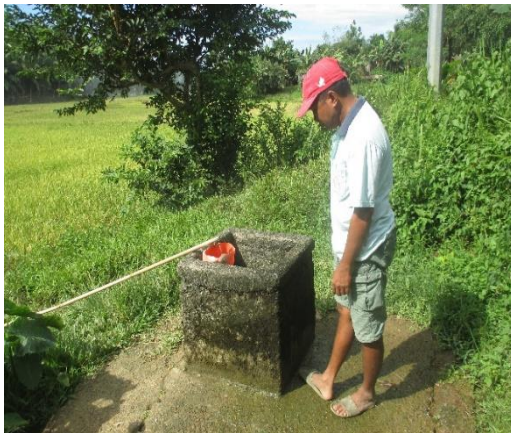
Barangay La Fortuna is one of the barangays of Veruela which is being serviced by the water district. However, a shallow well which has been used for five (5) decades is still being used for drinking by some residents. The well is about three (3) RCP culvert deep which is relatively open. Geographic coordinates N8° 01' 23.4"/ E125° 54' 32.8"

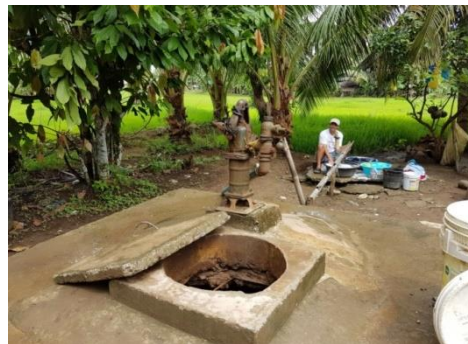
A shallow well (20ft) in Purok 2 of Barangay Napo which supplies Purok 2 and portions of nearby puroks. The well has no proper designed casing underneath which may cause the well's subsurface to collapse. Months of May to June were also noted to have less water to nil.

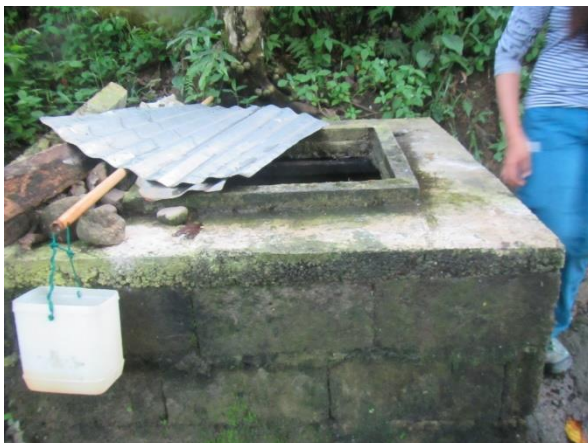
Concrete Box Captage in spring water source of Purok 10 Brgy. Patrocinio that uses rope and bucket. It is prone to contamination when intake box is not covered properly Geographic Coordinate: 7° 58' 7.6" N 126° 2' 53.34"E

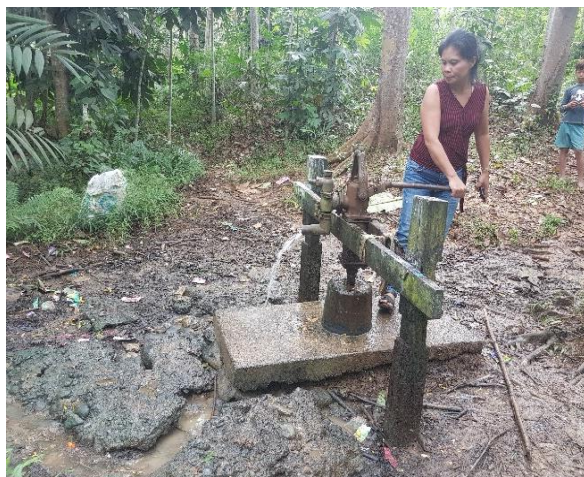
A shallow well (jetmatic type) with well depth of 30 ft. located at Purok 7, Barangay Marbon. It was constructed in 2013 and according to residents interviewed, they never experienced turbidity even during heavy rain and the water source is sufficient even during dry season.  
GPS location: N8°21'44.5", E125°47'20.1"
