#### PROGRAM 1: GEOLOGICAL RISK REDUCTION AND RESILIENCY PROGRAM

##### Geological Assessment for Risk Reduction and Resiliency Program (Geoscience Development Services)

##### Vulnerability & Risk Assessment & Updating

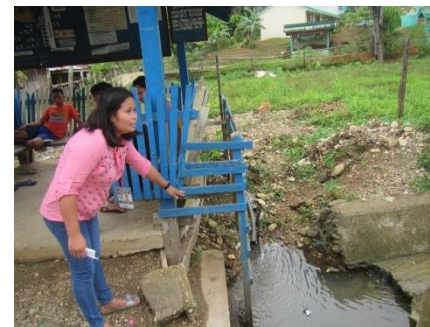
Brgy. Official in Buhisan showing the flood water level in Purok 5 during heavy rains. Geographic Coordinate: 8° 45' 3.81" N 126° 12' 24.96"E

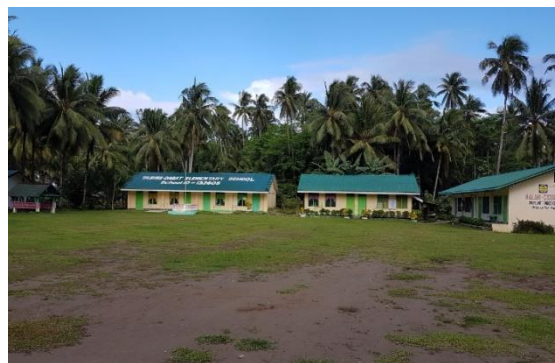
Tabing-Dagat Elementary School situated at Purok 1 of Barangay La Paz. The school previously serves as an evacuation center but the extent of the storm surge can reach the building. Currently, the school is no longer used as an evacuation center.

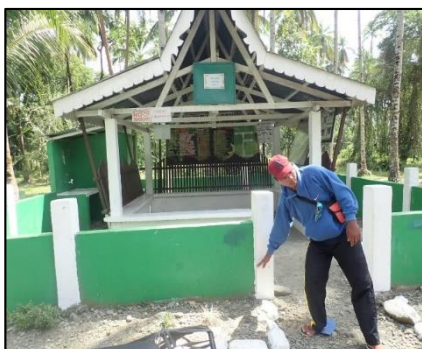
Photo showing the flood height located in Purok 1, Brgy. San Vicente.

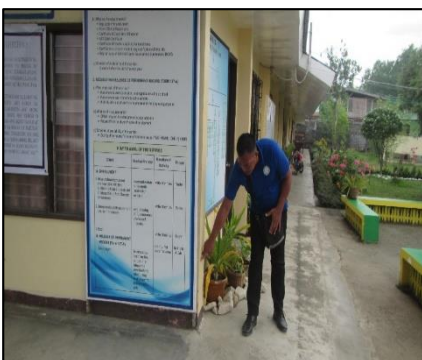
Photo showing the flood height in the premises of Madrid National High School located in Purok 2 which indicates low flooding susceptibility. GPS Coordinates: N9.25986 E125.96628

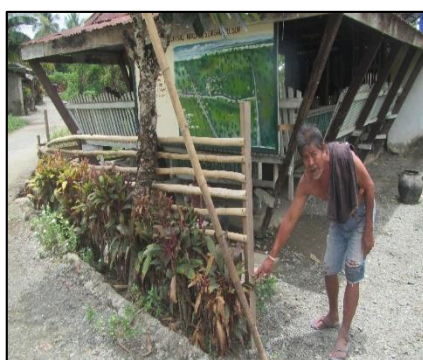
Photo showing the flood height (low flooding) of Purok 5, Brgy. Quirino experienced. GPS Coordinates: N9.25918 E125.95891

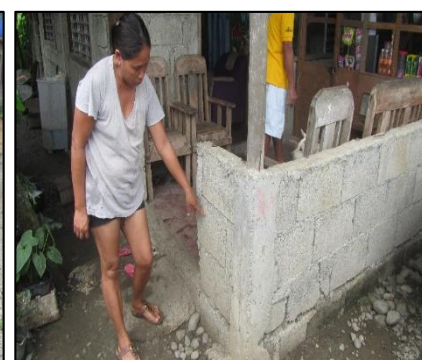
According to interview, they experienced moderate to flooding during TS Basyang that happened last February, 2018. GPS Coordinates: N9.27352 E125.95881

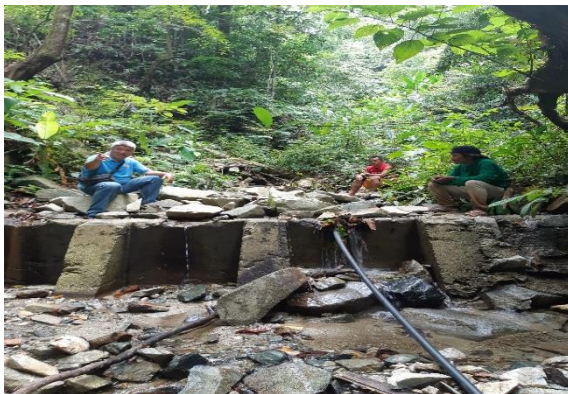
Photo shows a concrete box installed to the surface water source (creek) of Barangay San Isidro. It supplies 5 Puroks (1, 2, 3, 4, and 5) of the Barangay and is mainly used for drinking. The water never dries out but is turbid during heavy rains and rainy season. GPS coordinates: 8° 28' 45.0717" N, 125° 58' 30.2978" E.

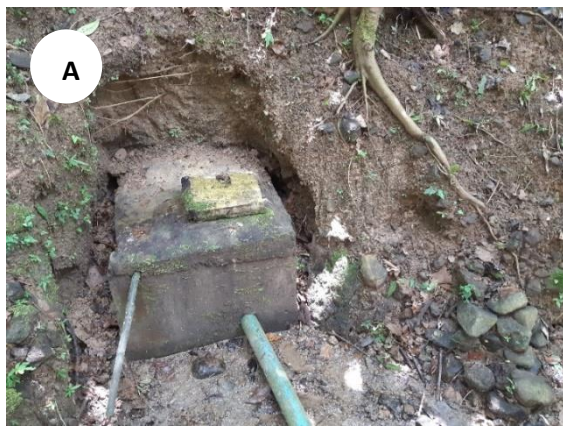
Photo A and B show the Water Supply and Sanitation (WATSAN) Project which is from a spring source located in Purok 8 of Barangay San Teodoro. The project was handed to Bunawan Water District in 2016. It supplies the 200 households of the Barangay and is used for drinking and other domestic purposes. GPS coordinates: 8° 11' 40.3474" N, 126° 00' 27.1757" E (spring-A) and 8° 11' 27.1343" N, 125° 59' 51.1900" E (reservoir-B).

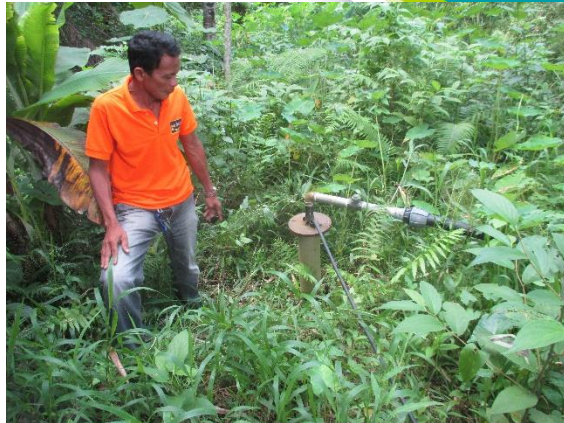
Level II deep well supplying drinking water to Puroks 3, 4, and 5 in Barangay Limot. The well is approximately 120 feet deep and is located at a lower elevation than the barangay, hence the use of submersible pumping to extract the groundwater. It is also located along a gully which is a natural drainage for surface runoff during rainy days. Geographic coordinates N7° 57' 48.2"/ E125° 53' 16.3"

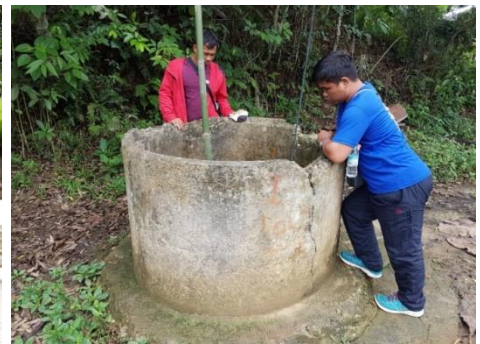
An open dug well situated in Purok 7 of Barangay La Union. The well was constructed via 'bayanihan' by the local residents in the barangay due to insufficiency of funds. It was constructed approximately 30 years ago and supplies Purok 6 and Purok 7.

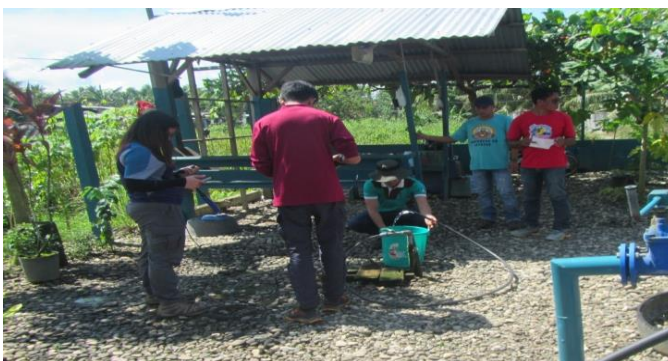
Photo shows the pumping station 6 of Bayugan Water District, this station is located at Purok 4 of Barangay Bucac, Bayugan City. This deepwell has a depth of 96m, and it started to operate on January 2016. It is one of the sources that supply the Bayugan City proper.

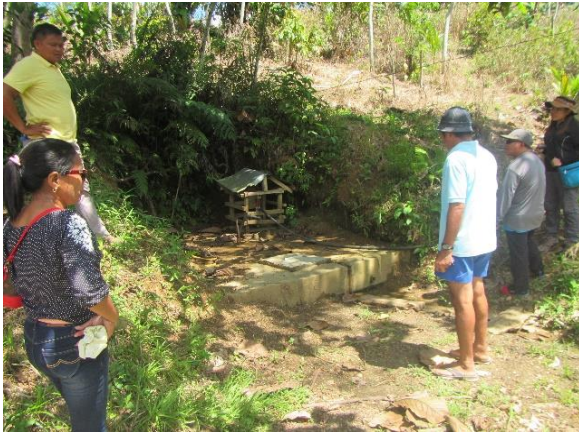
Spring source located at Purok 1, Brgy. San Isidro which is extracted through a pressurized pump. Most residents of this barangay utilized this for domestic use.

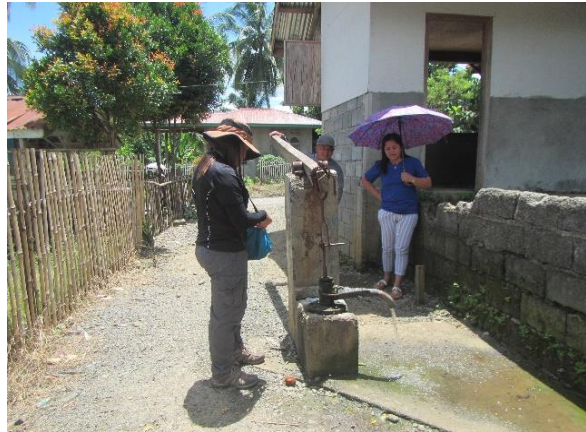
A 60 ft.-deep shallow well in Purok 3, Brgy. San Vicente which used as drinking water source by some residents of this barangay according to a barangay official.

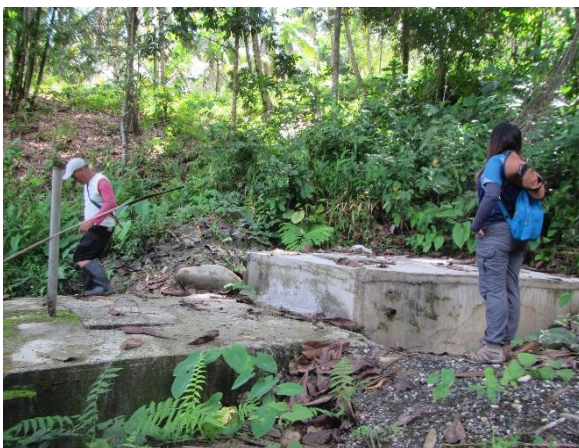
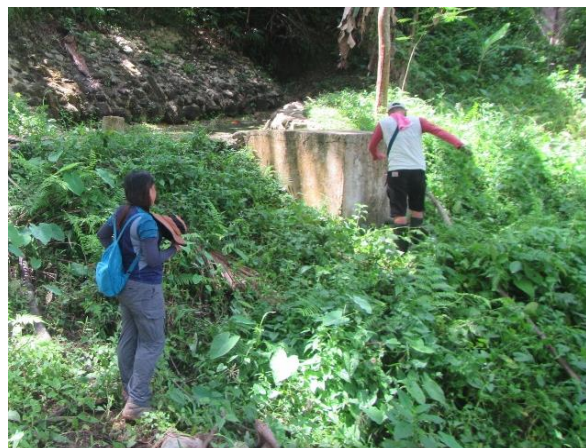
Spring sources in Purok 6 (right photo) and Purok 7, Brgy. Bayugan 3 (left photo) which is joined into one reservoir, a barangay project aided by Philsaga Mining Corp. as part of their SDMP (Social Development and Management Program). Both the sources are in level III water distribution.

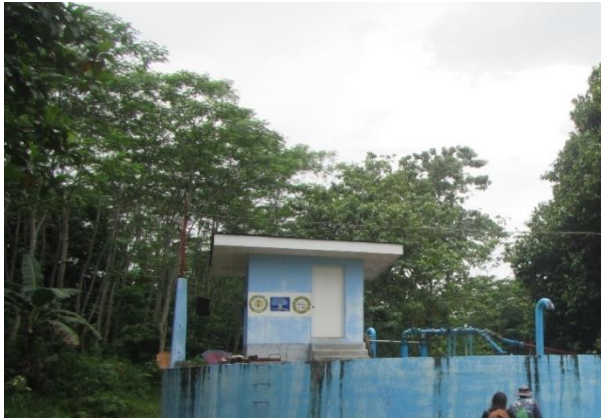
Spring source in Purok 1, Brgy. Basa which is a Salintubig Project. This is used as drinking water source of most residents in this barangay and the municipal water association of Trento has a plan to also use this as municipal-wide water source.

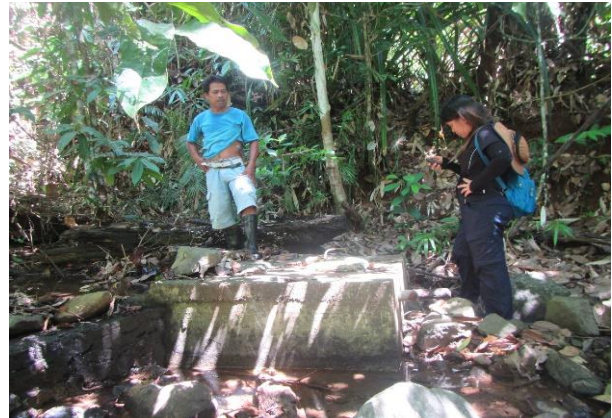
Spring source located in Purok 1, Brgy. Pangyan. It is a project by the Province of Agusan del Sur and was constructed in 2014.

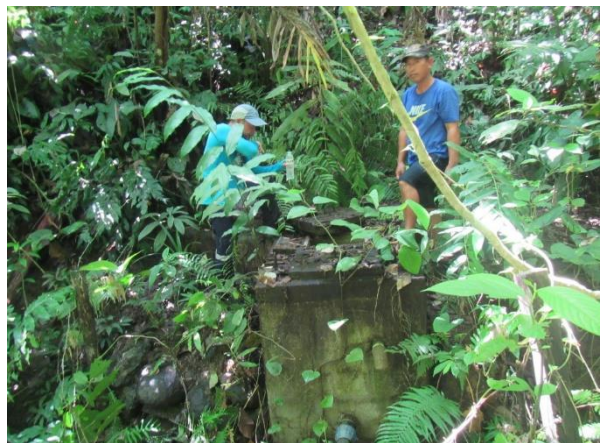
Closed Concrete Box Captage Type of the spring water source in Purok 9, Brgy. Sayon. Geographic Coordinate: 7° 58' 22.5" N 125° 58' 5.7"E
